**ASBESTOS AND LEAD SURVEY  
BEVERLY HILLS FIRE STATION NO. 2  
1100 COLDWATER CANYON DRIVE  
BEVERLY HILLS, CALIFORNIA 90210**

January 9, 2017  
Project No. 209914001

Subject: Asbestos and Lead Survey  
Beverly Fire Station No. 2  
1100 Coldwater Canyon Drive  
Beverly Hills, California 90210

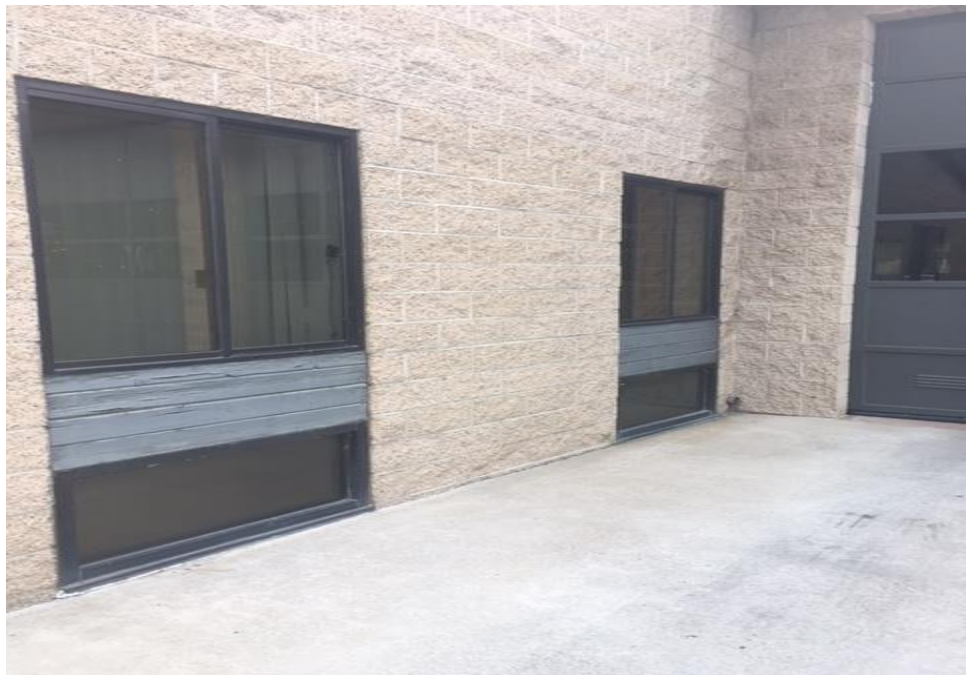
**Photograph 2: View of lead containing brown exterior window frames.**

- The identified LCSs should not be disturbed. Removal activities should be performed by a licensed abatement contractor with certified lead personnel. All lead related removal activities should be performed in accordance with the DOSH Lead in Construction Standard, Title 8 California Code of Regulations (CCR) 1532.1.

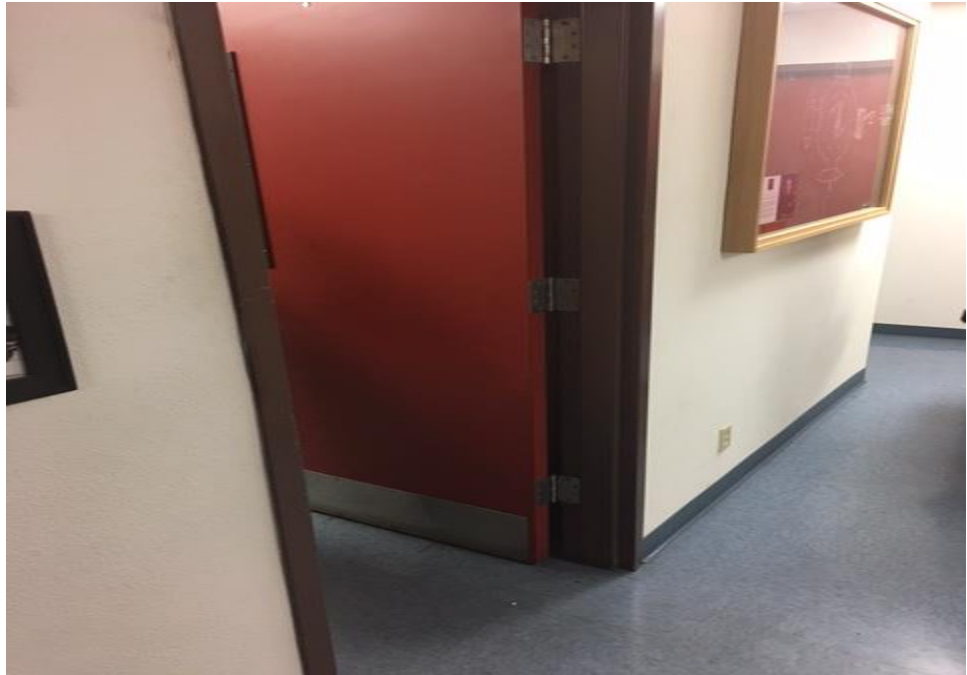
**Photograph 3:** View of representative lead containing red door and brown door frame.

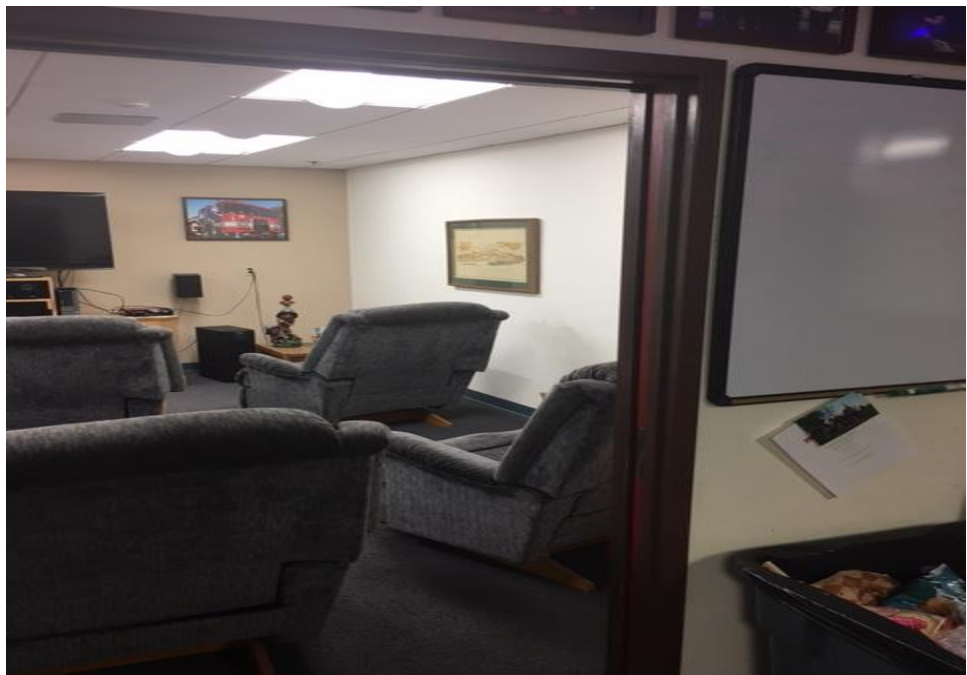
**Photograph 4:** View of lead containing sliding brown door and brown door frame.

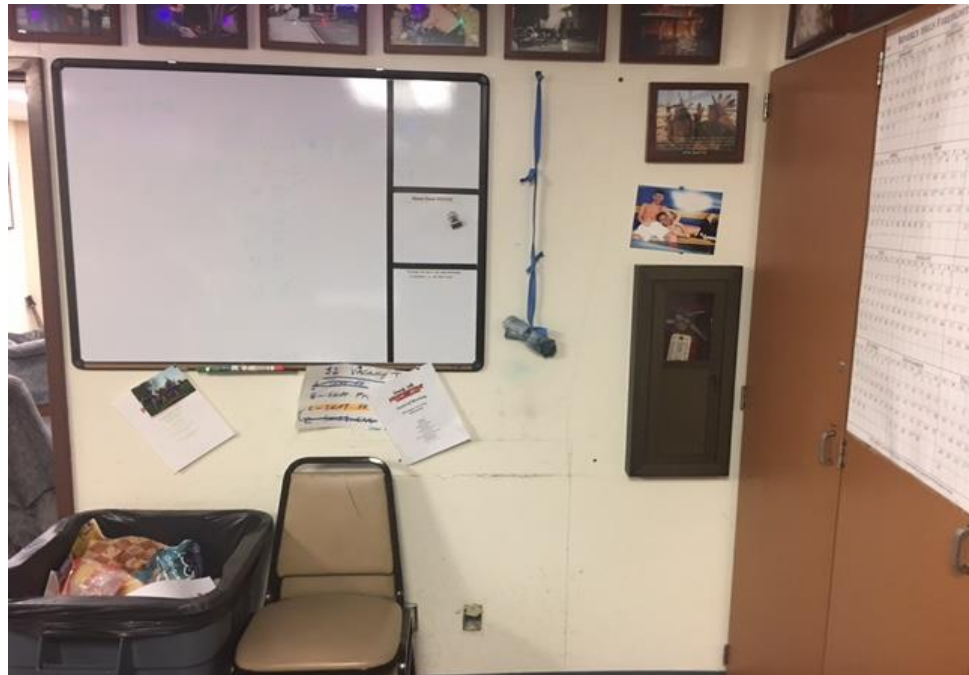
**Photograph 5: View of lead containing white wall from kitchen location.**

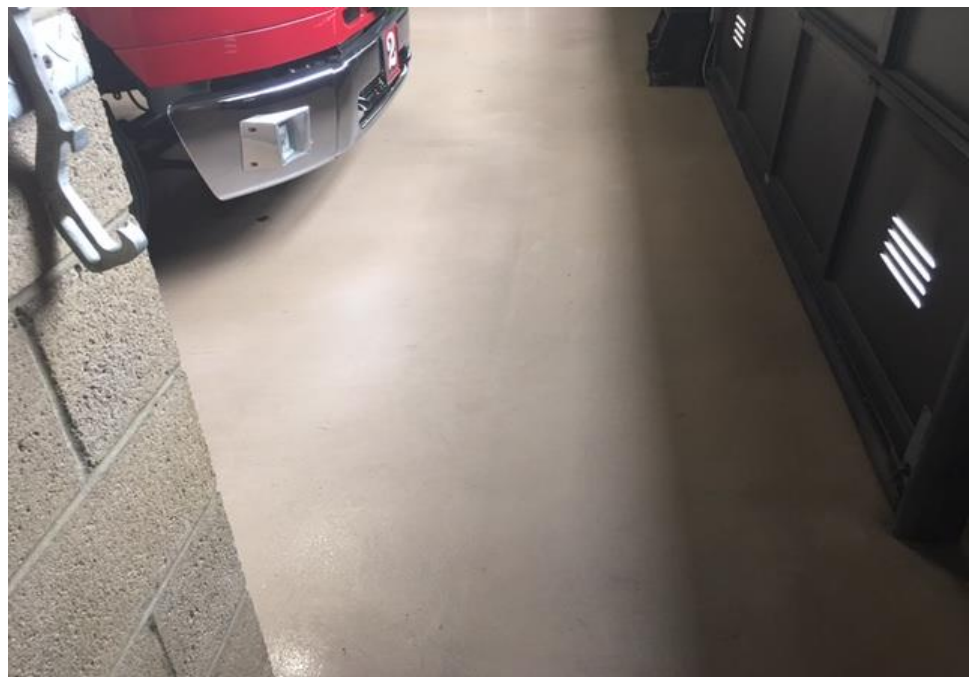
**Photograph 6: View of lead containing gray flooring within Apparatus area.**

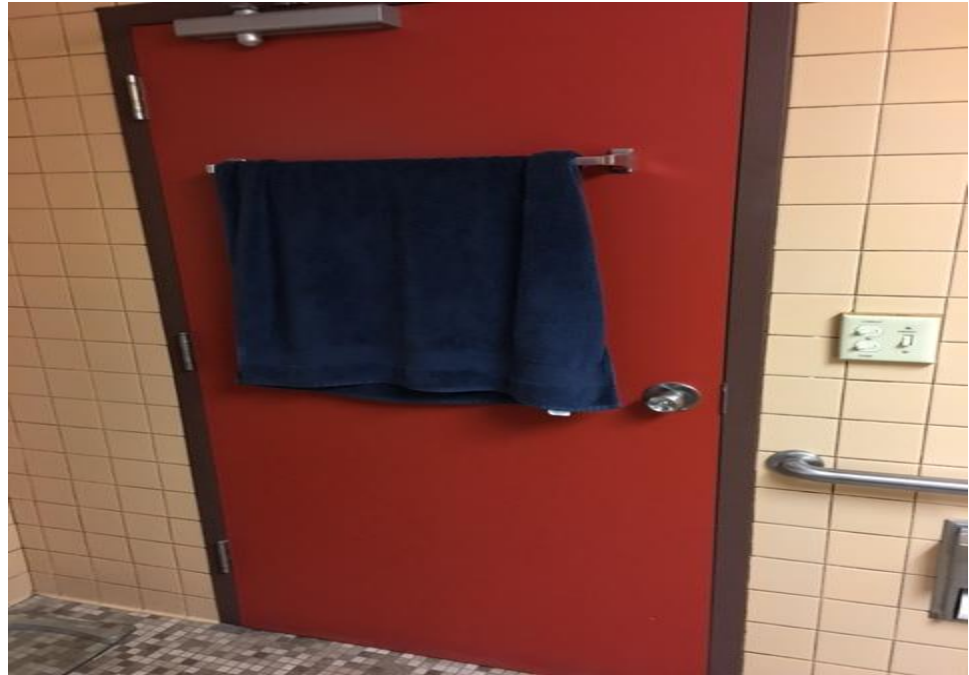
**Photograph 7:** View of lead containing red door/ brown door frame within the Captain's restroom.

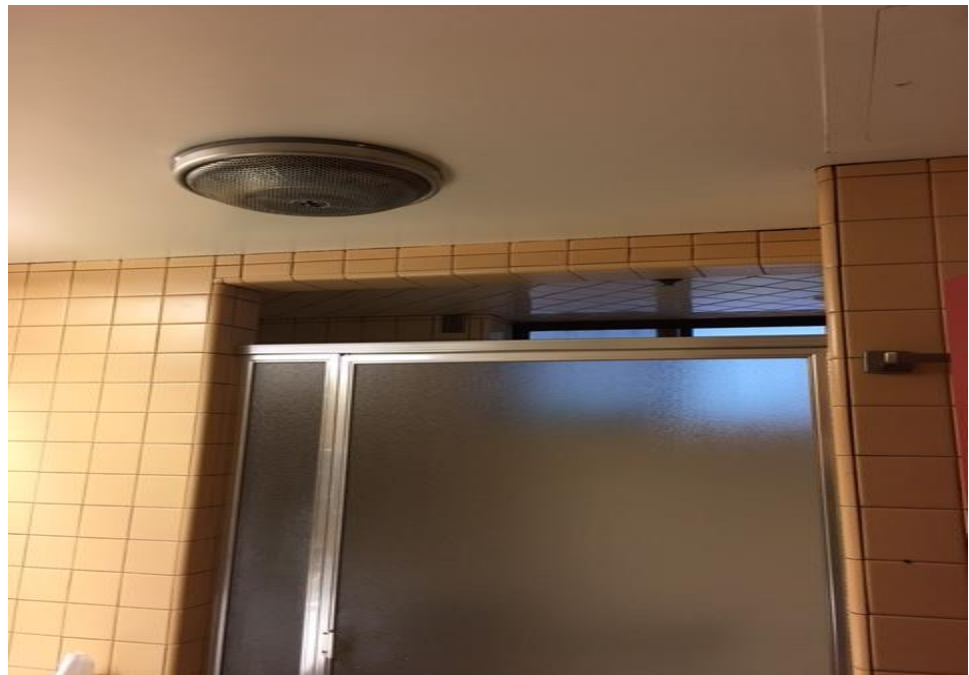
**Photograph 8:** View of lead containing black window frame within the Captain's restroom.
